Impervious Surface Analysis Sussex County, Delaware Coastal Communities Enhancement Initiative

This CommunityViz analysis estimates the impervious surface for an area southeast of Milton, Delaware. The project is in the Broadkill watershed in Sussex County. At 10 percent imperviousness, a large drop-in stream water quality occurs.

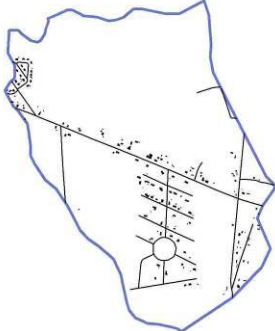
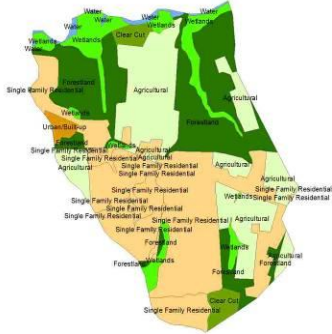
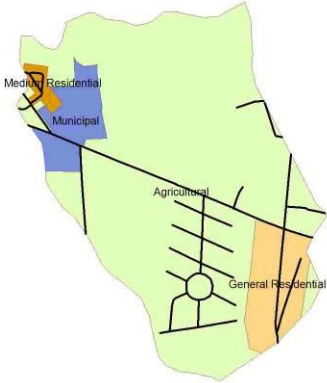
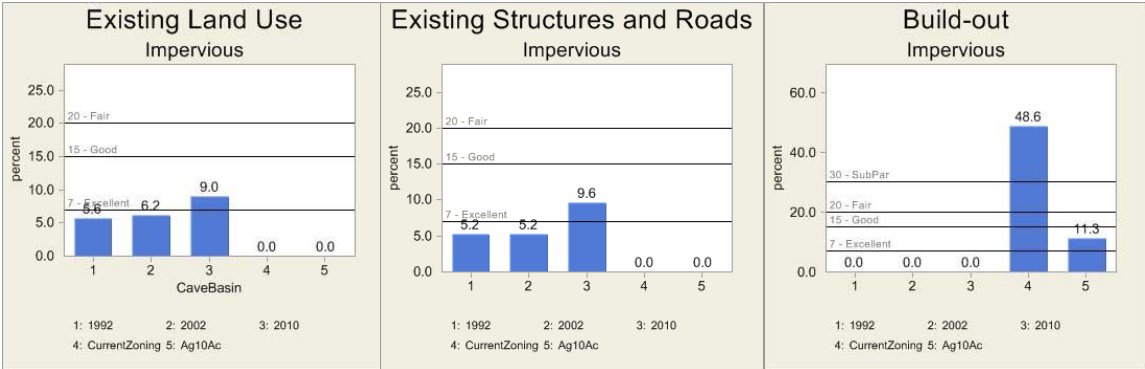
The land use based impervious surface analysis uses the State 1992 and 2002 Land Use layers. The feature analysis uses building footprints and roads. The 2010 scenarios include building a PLUS project (2006-10-03) into Milton on Cave Neck for 370 units on 71 acres. The build-out includes Current Zoning and Ag10Ac assumes agricultural areas use 10 acre lots (not .5 acres).
